TIHONET POND NO. 2 DAM

MA 00030

PHASE I INSPECTION REPORT
NATIONAL DAM INSPECTION PROGRAM

JULY 1981

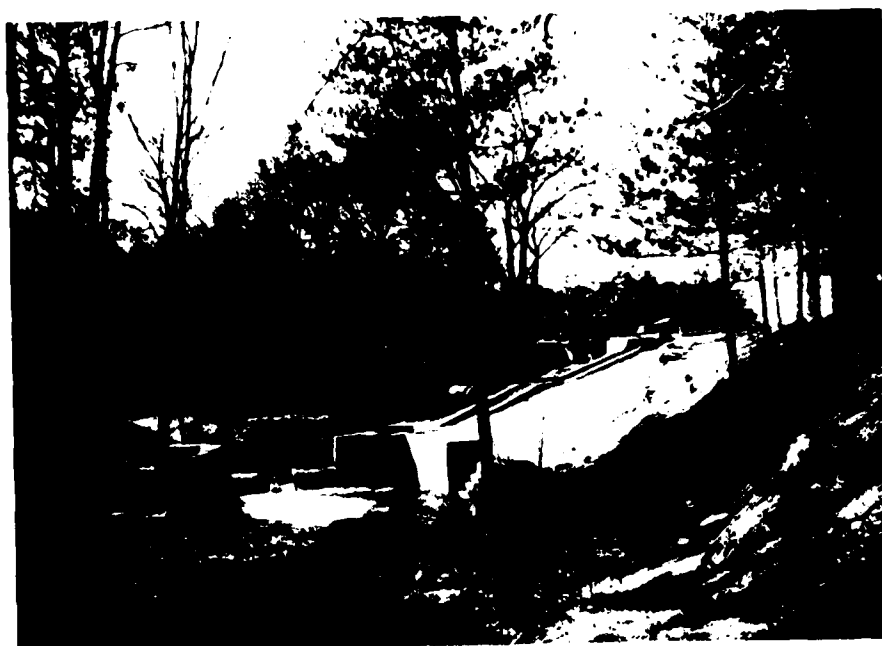
Photo # 11 Downstream Slope Tihonet Pond #1 Dam
